**Intercontinental Terminals Company (ITC) Fire Update  
Deer Park, Texas  
May 1, 2019 0000 – May 1, 2019 1159**

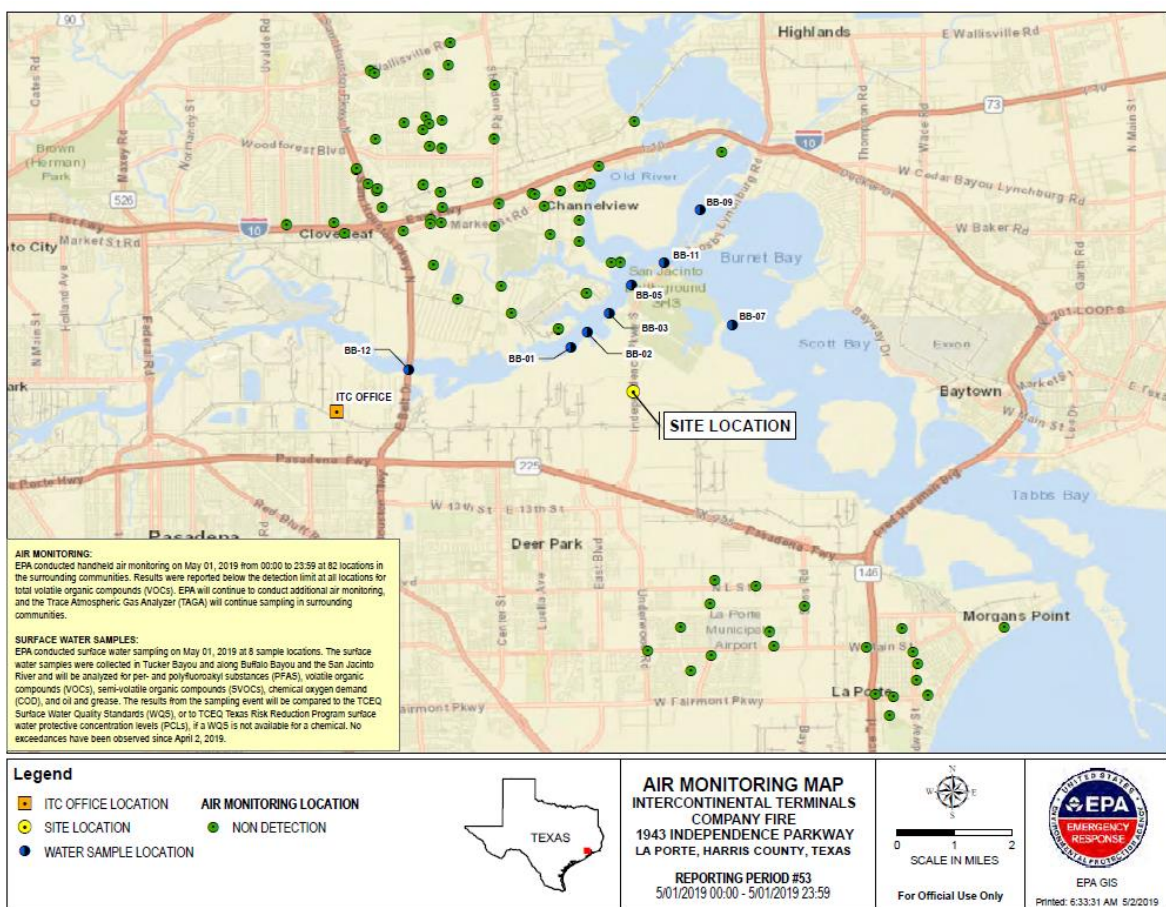
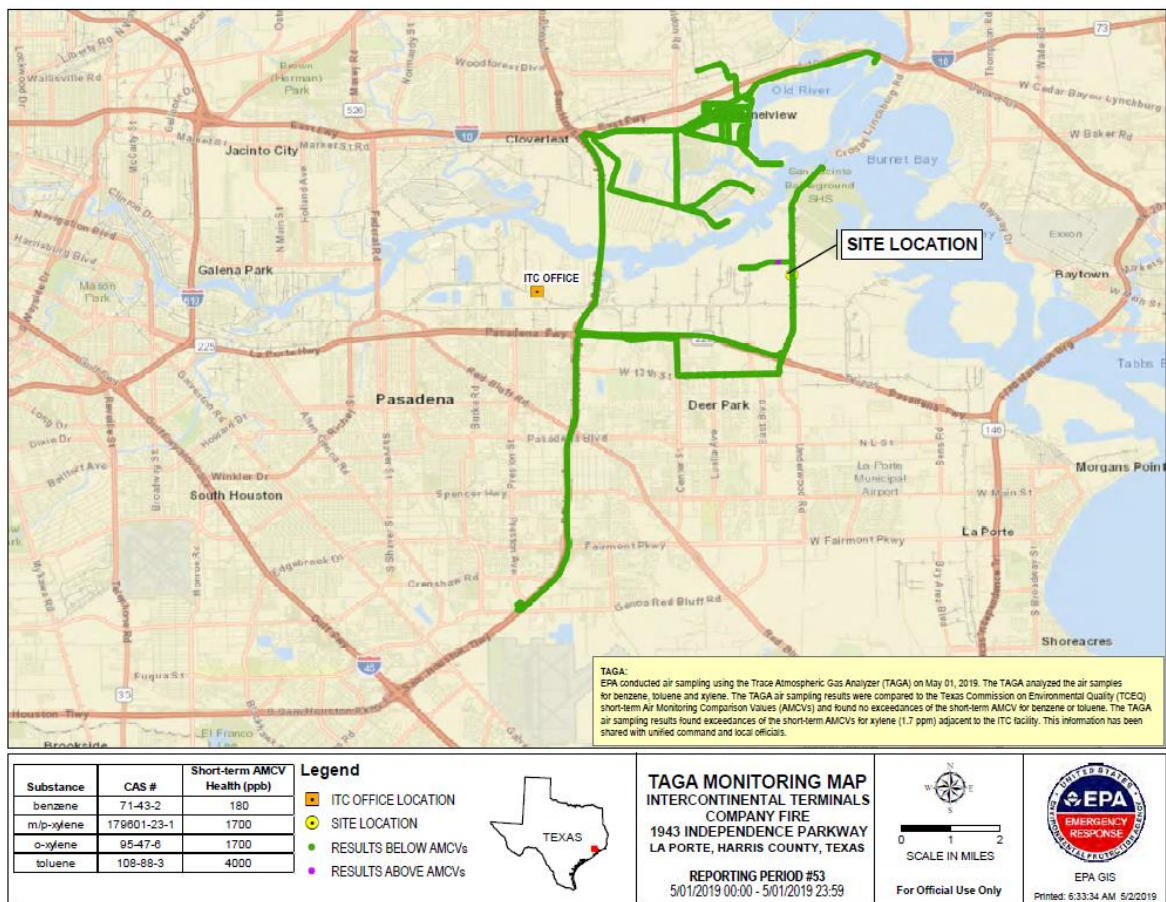
## Additional Information: Air Monitoring and Water Sampling locations:

- EPA conducted surface water sampling on May 01, 2019 at 8 sample locations. The surface water samples were collected in Tucker Bayou and along Buffalo Bayou and the San Jacinto River and will be analyzed for per- and polyfluoroalkyl substances (PFAS), volatile organic compounds (VOCs), semi-volatile organic compounds (SVOCs), chemical oxygen demand (COD), and oil & grease. The results from the sampling event will be compared to the TCEQ Surface Water Quality Standards (WQS), or to TCEQ Texas Risk Reduction Program surface water protective concentration levels (PCLs), if a WQS is not available for a chemical. No exceedances have been observed since April 2, 2019.

- Several entities including TCEQ, EPA, and ITC continue to conduct air monitoring around the tank farm, in adjoining industrial areas, and communities downwind from the facility.
- EPA conducted handheld air monitoring on May 01, 2019 from 00:00 to 23:59 at 82 locations in the surrounding communities. Results were reported below the detection limit at all locations for total volatile organic compounds (VOCs). EPA will continue to conduct additional air monitoring, and the Trace Atmospheric Gas Analyzer (TAGA) will continue sampling in surrounding communities.
- EPA conducted air sampling using the Trace Atmospheric Gas Analyzer (TAGA) on May 01, 2019. The TAGA analyzed the air samples for benzene, toluene and xylene. The TAGA air sampling results were compared to the Texas Commission on Environmental
